Repair or Replace

Windows in Historic Buildings: Arriving at a Sustainable Solution

BY CRAIG SIMS AND ANDREW POWTER

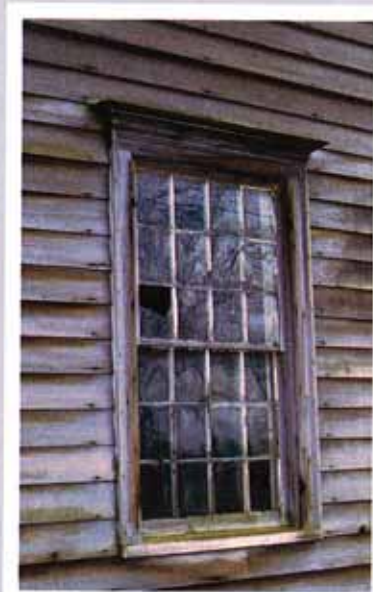
Although not maintained for years, this 200-year-old window still shows the three-dimensional features of the drip cap and sill which are missing from most modern windows. / Même si elle a été privée d'entretien pendant des années, cette fenêtre de 200 ans exhibe encore les caractéristiques tridimensionnelles du larmier et de l'appui de fenêtre qui sont absentes de la plupart des fenêtres modernes.

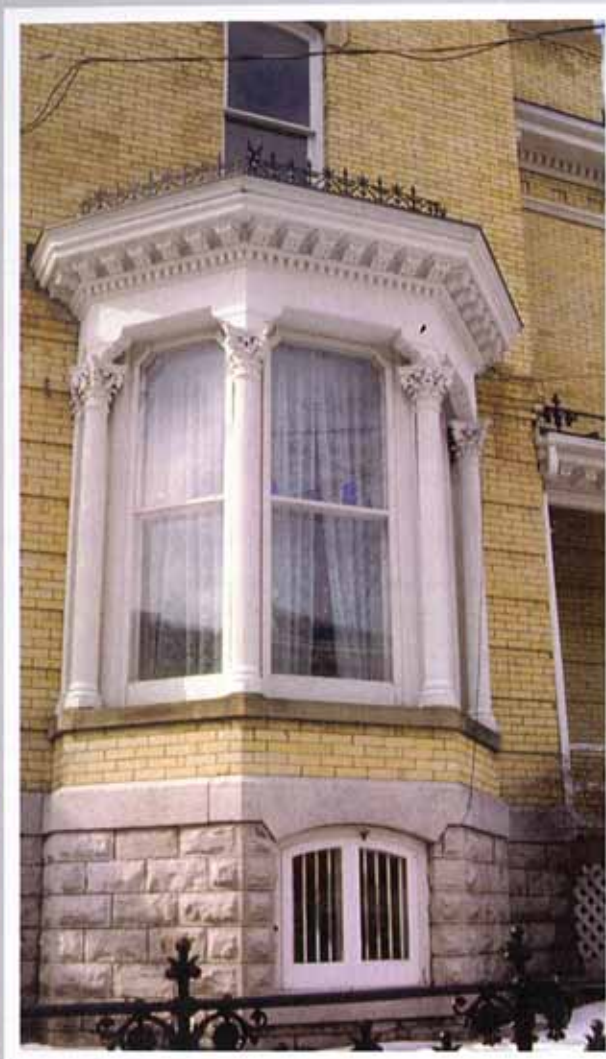
The original bay window is a significant element of this Kingston, Ontario house. / La fenêtre en baie est un élément significatif de cette maison à Kingston (Ontario).

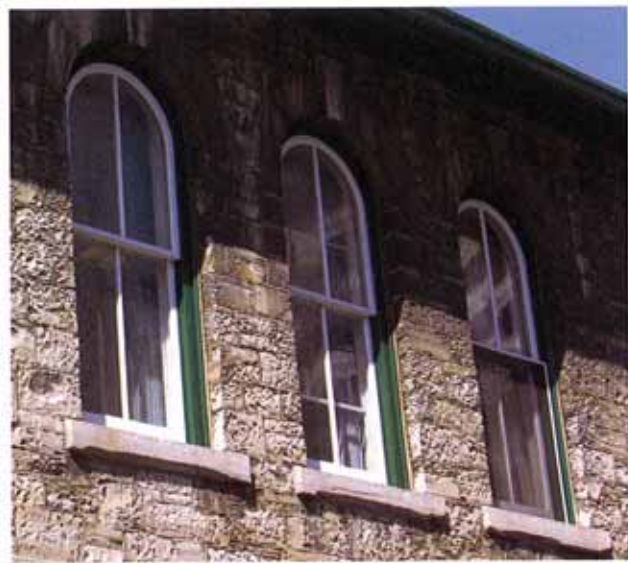
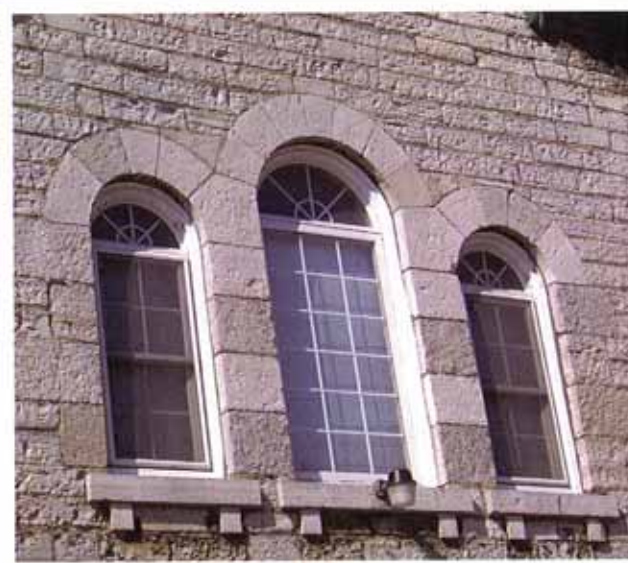
Top: the simple two-over-two glazing pattern of these original windows contributes to the Italianate features of the historic school building, whereas the overly fussy and fake appearance of the vinyl replacement windows (above) is a major distraction. / En haut : Le simple motif deux sur deux du vitrage de ces fenêtres d'origine contribue aux traits italianisants de cet immeuble scolaire historique. En revanche, l'apparence exagérément recherchée et fautive de ces fenêtres de remplacement en plastique (ci-dessus) est une grande source de distraction.
