What's happening at 5 Blackburn Avenue? A simple roof job with behind-the-scenes drama

HCF's executive director, Natalie Bull, reports on this summer's roofing project.

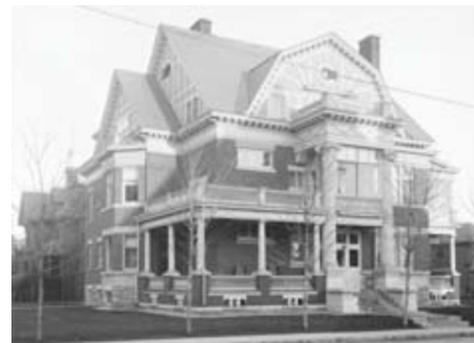
1079, Library and Archives Canada

The historic views confirm that slate was the original roofing material—and reveal the staggering number of changes this building has undergone in its 100 years. For one thing, the entire roof line had been drastically altered. Originally a high, steeply pitched gable roof, with a prominent gambrel-roofed (barn-shaped) dormer over the main entrance, and four pitched-roof bays on the other elevations, it was changed, at some point, to a lower, squatter gambrel design. Few of the roof planes and gables retain their original geometry, and the overall impression of the building is lower and heavier than the design intent. Was there a fire? Were there structural issues associated with the weight of the slates? We hope additional documentary and physical evidence will provide answers. But one thing is sure: the roof that once supported slate shingles no longer exists.

The photos reveal even more changes. The gable fronts had been elaborately finished with mock half-timbering (stucco divided into panels by wood mouldings, simulating the effect of medieval construction techniques) that emphasized the vertical nature of the building. The later introduction of the recycled slate to these surfaces results in a more sombre, weighty finish. The intended lightness, texture and whimsy so characteristic of the Queen Anne Revival style were further undermined by the loss of a towering three-storey entrance porch, and a delicate front/side verandah with slender vertical members.

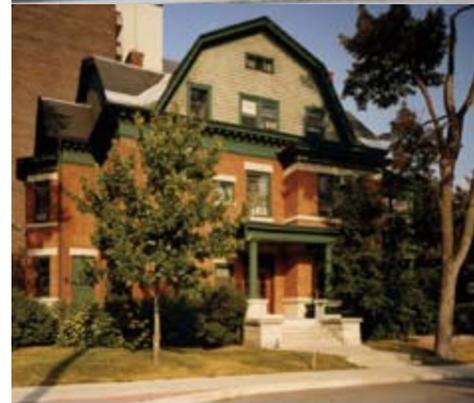
PHOTO : HCF

5 Blackburn Avenue in June 2006

This summer, we replaced the asphalt shingle roof of HCF's headquarters in Sandy Hill with new asphalt shingles—a seemingly banal operation. However, some basic research opened up a line of inquiry that forced some careful thought about our conservation approach for the building.

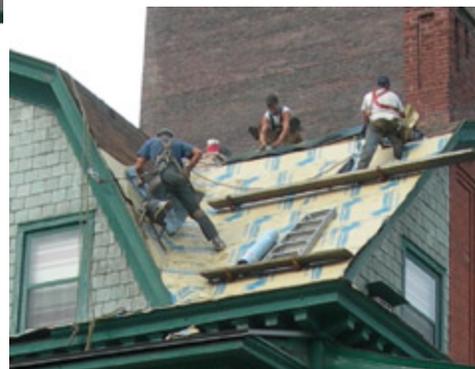
The unusual three-sided valley configuration, which survives from the building's earliest days, was retained and flashed with new metal.
