Saskatchewan Heritage Foundation
CONSERVATION BULLETIN SERIES

Roof

R*oof* - This Conservation Bulletin discusses roofs as architectural assemblies that have both functional and decorative elements that help define the architectural character of the historic building. Roof features include cupolas, parapets, chimneys, gutters, dormers, and bracketed eaves.

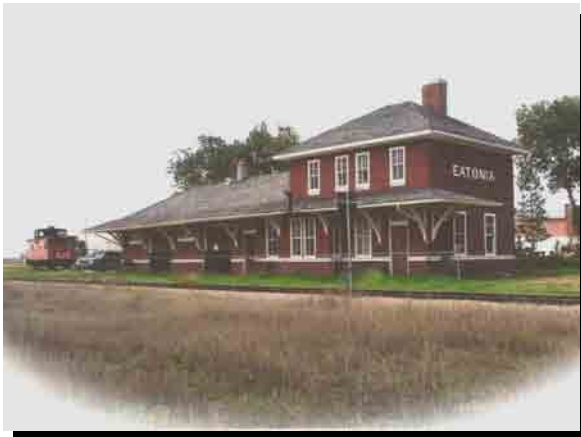
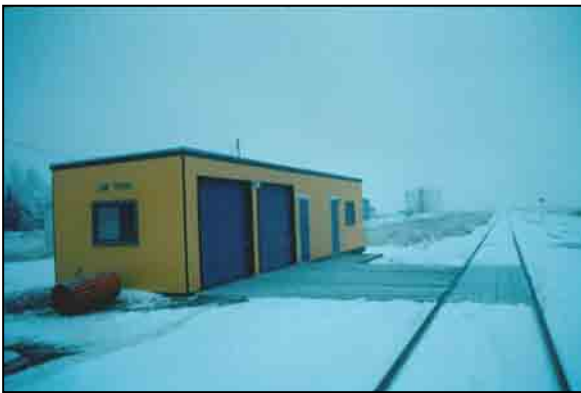
CNR Station (top); VIA Station, Eatonville SK

The railway station's architectural form and plan were determined by its function and eloquently expressed with decorative features such as the heavy overhanging eaves which also served many functional purposes.

Generous overhanging eaves provided shelter from the blistering sun and driving rain, and the ornate brackets divided the long expanse into sections that added privacy for those clustered below just off the busy platform. The overhang also protected luggage stacked on carts out of the rain. Under the beautiful overhang, loved ones found a space of privacy and intimacy to say hello or embrace in final farewell before leaving for war or places far from the safety of home.

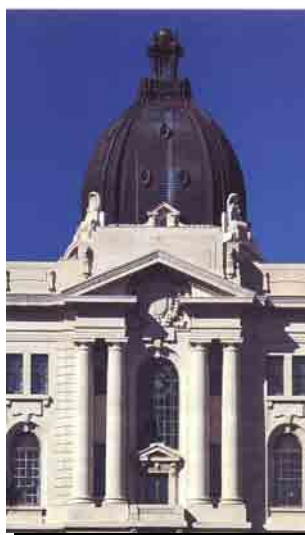
*Legislative Building Dome, Regina SK
The dome was once available for public tours*

The parapet wall on the Provincial Legislative Building and appropriately coloured exterior finishes were used to mask installation of new mechanical rooftop service equipment. Somewhat visible from the west side, effort was made to make the enclosures as inconspicuous as possible.

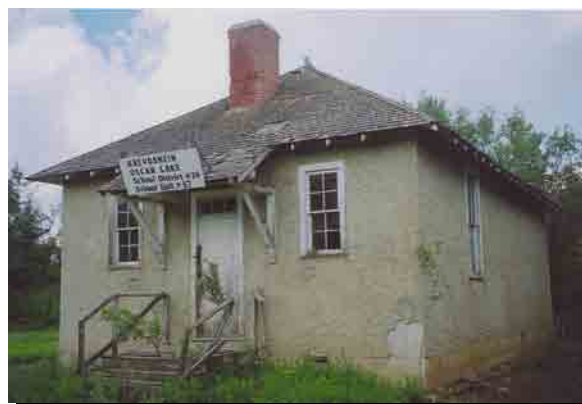
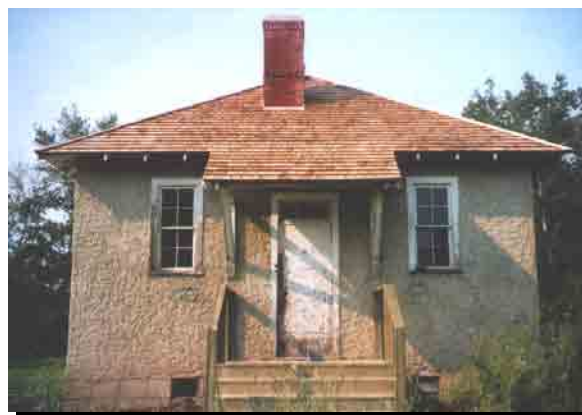
***Krivoshein / Oscar Lake School
Meeting Lake RM 466, near Hafford***

(top) Before roofing repairs.

(bottom) After application of new wood shingles.

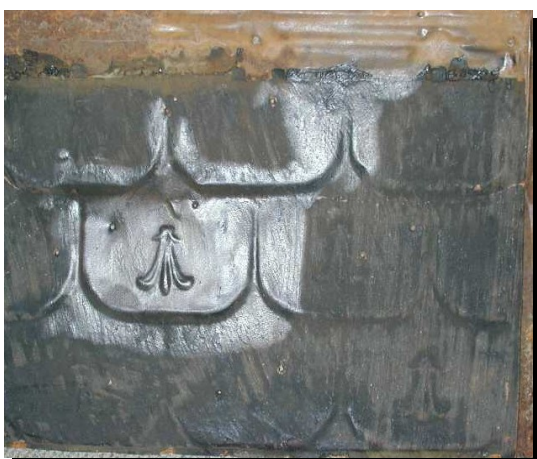
Town Hall / Opera House, Prince Albert SK
Fleur de Lys design (18 x 22 inches)

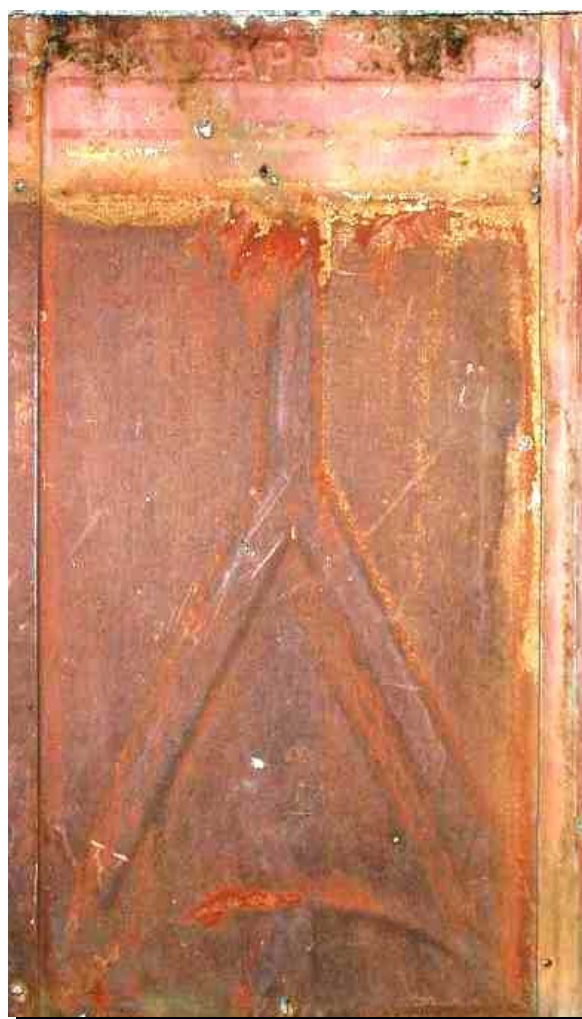
Land Registry Office, Battleford SK
Inverted "Y" design (9 x 14 inches)

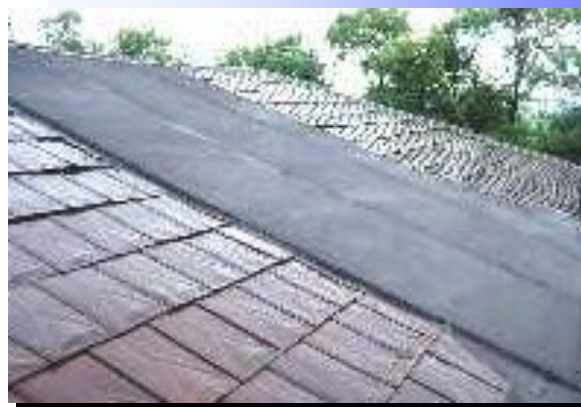
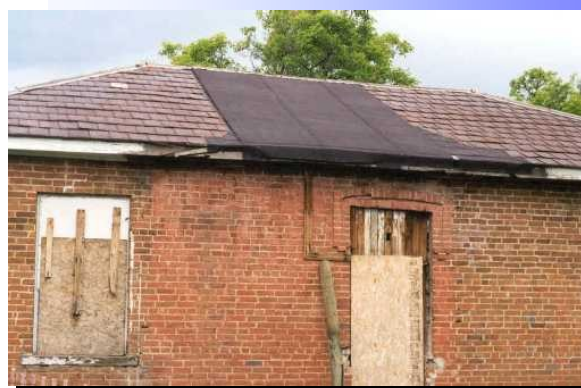
Land Registry Office, Battleford SK

Asphalt Patch on Metal Shingle Roof - changing from metal shingles to wood or asphalt significantly alters the appearance of an historic building.
