Capturing Light

Maintaining The Beauty Of Stained Glass

by Susan D. Turner

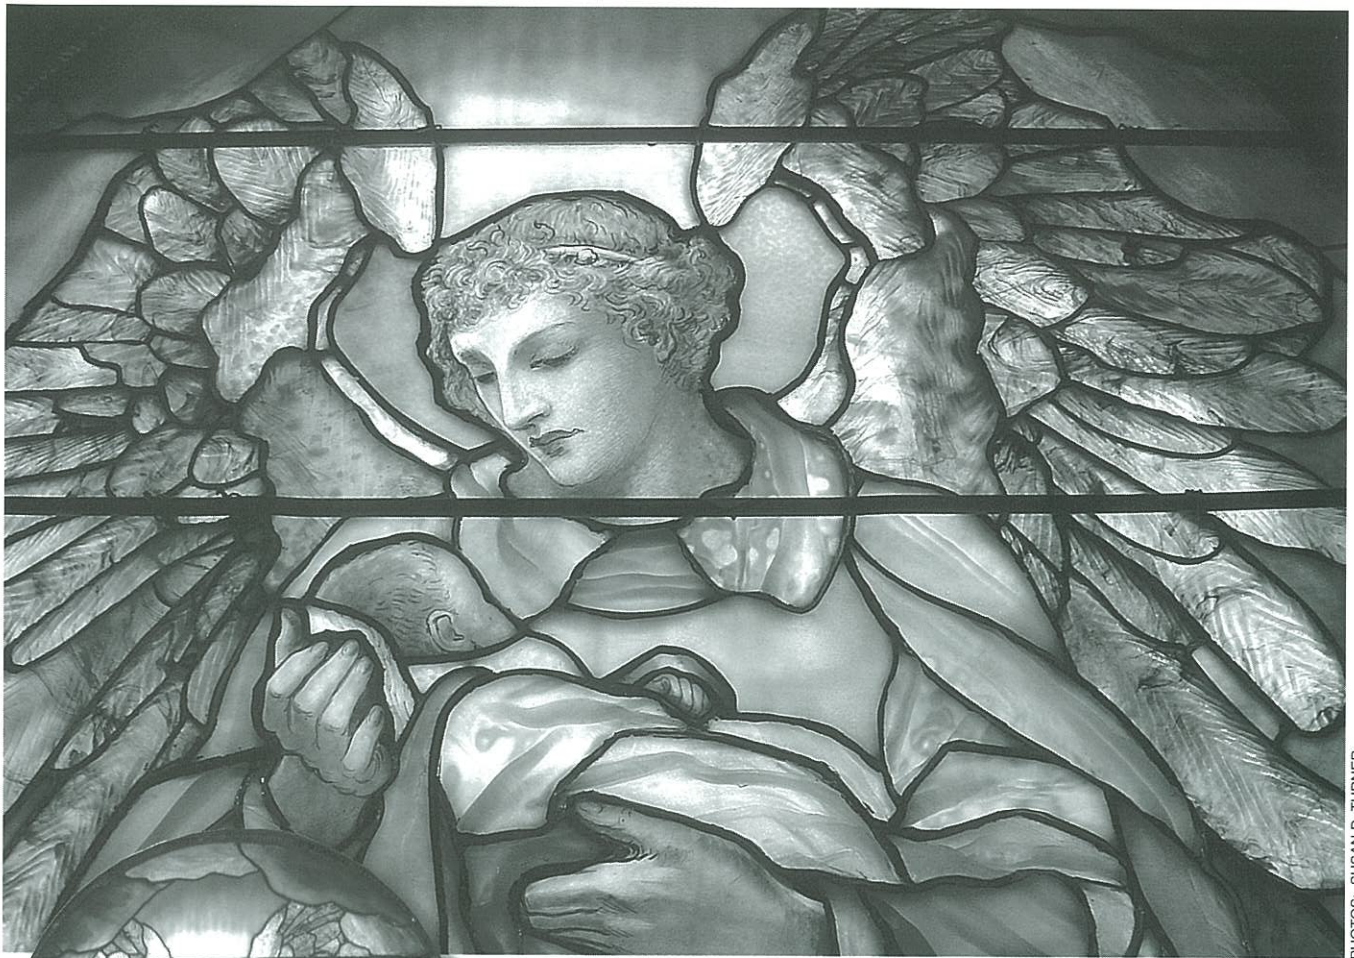
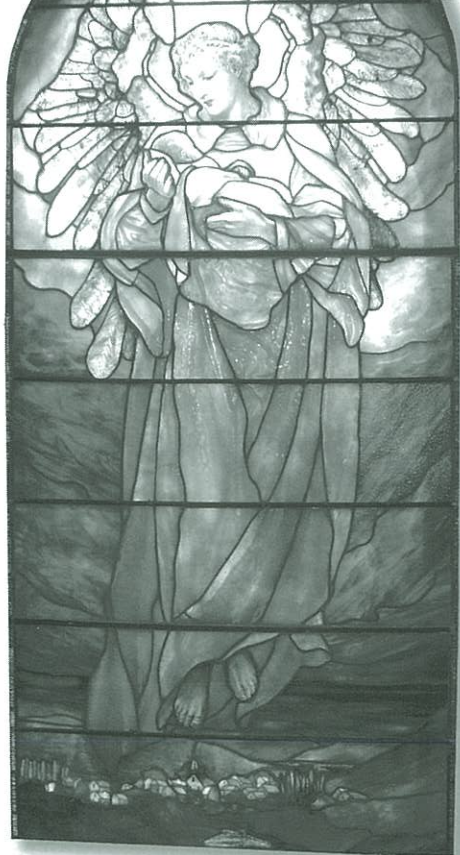
A Tiffany glass window was discovered intact behind wood siding in a former Unitarian church in Ann Arbor being renovated for office use by Hobbs and Black Architects. Tim Osius, a stained glass artist, removed the window, cleaned it with water alone, and added several saddle bars to support sagging in the glass. The rest of the comes were stabilized as found, and the window was installed. During this work, he uncovered the words "Tiffany Studios," dating it to ca. 1902. Further research authenticated that the piece was by Tiffany.
