HAMILTON LANDMARK GLOWS AGAIN

The Lister Block emerges from decay to glory, rejuvenating the city's downtown.

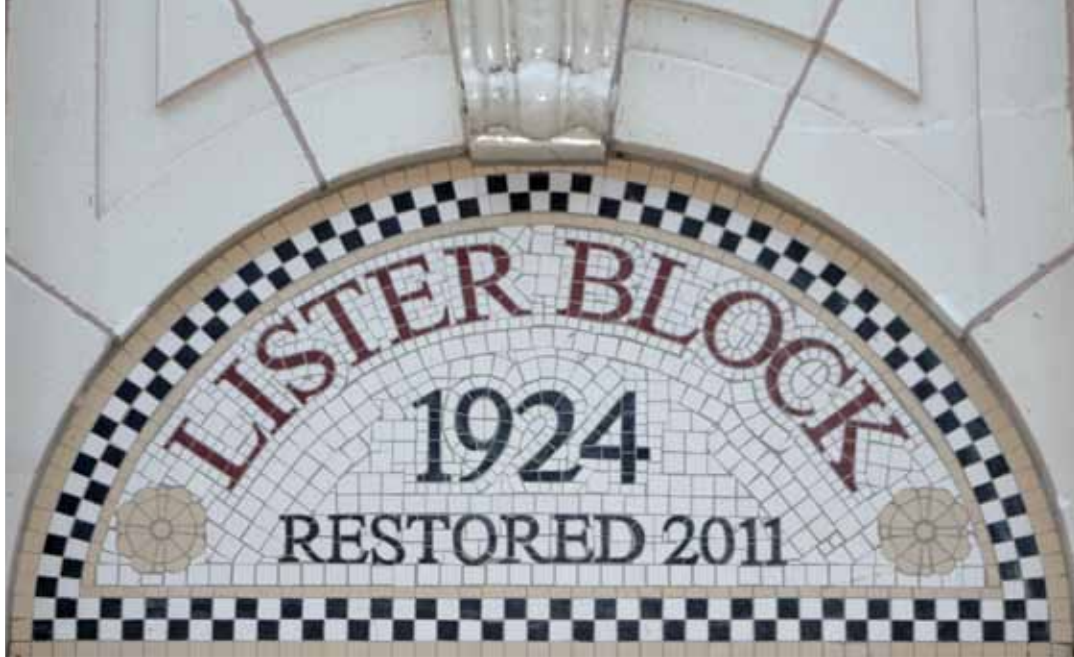
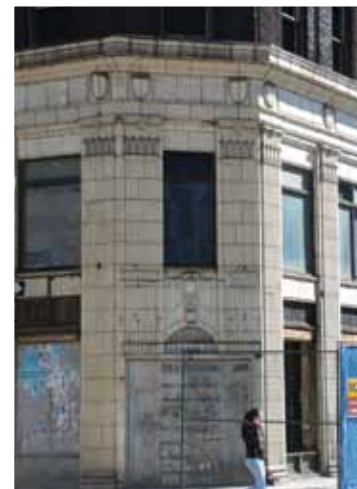
With lights ablaze, the Lister Block shows the shining results of its rehabilitation last May. Final landscaping work is still under way.

Inset: View of the deteriorated state of the building's main entrance and its glazed terra cotta exterior (2009).

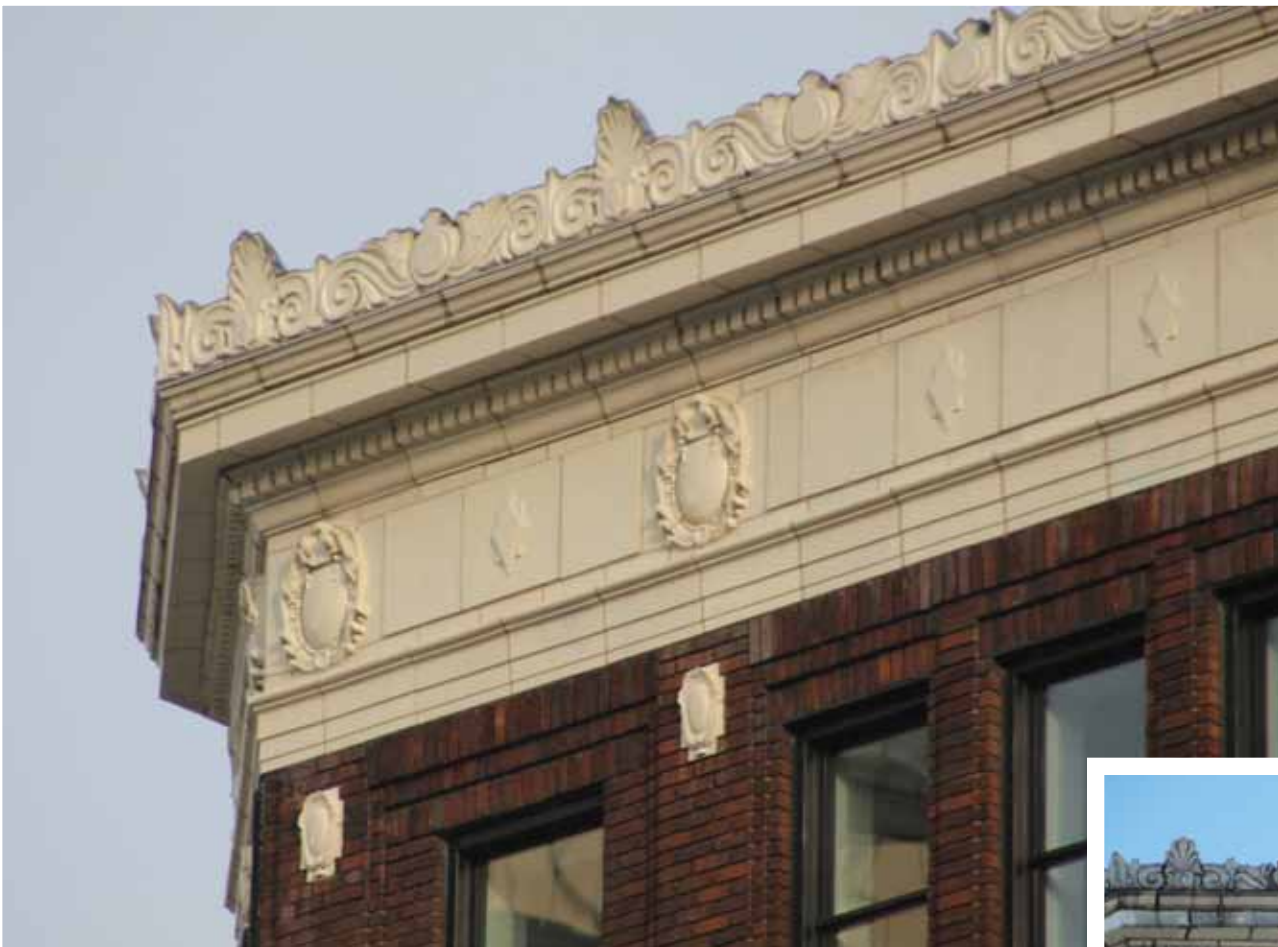
The cream-coloured glazed terra cotta cornice was retained and meticulously repaired and the exterior brown rug brick carefully cleaned and re-pointed.

Inset: Photo of same before restoration work began.

The Lister Block's famous dark rug brick exterior, unchanged since 1924, was cleaned and re-pointed. The terra cotta was removed, repaired and re-installed with new fasteners. Where it was too damaged, pre-cast concrete replicas were used. The original wooden window sashes on the third

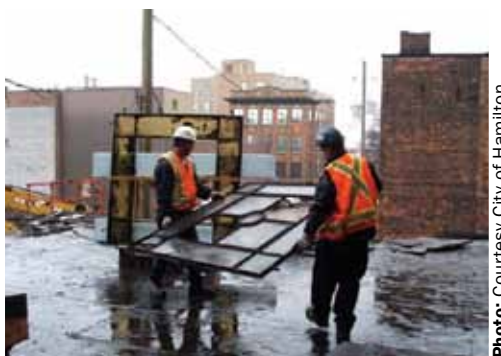
Workers carefully salvaged the skylight sash (inset) before it was restored and re-installed in the arcade ceiling (above).

what remained in the two original skylights that were hidden behind a false ceiling. Although the plasterwork on the first floor was beyond salvage due to water infiltration, enough material remained to allow it to be fully reproduced. The second-level terrazzo floor was ground and polished. The two staircases with marble treads were restored.

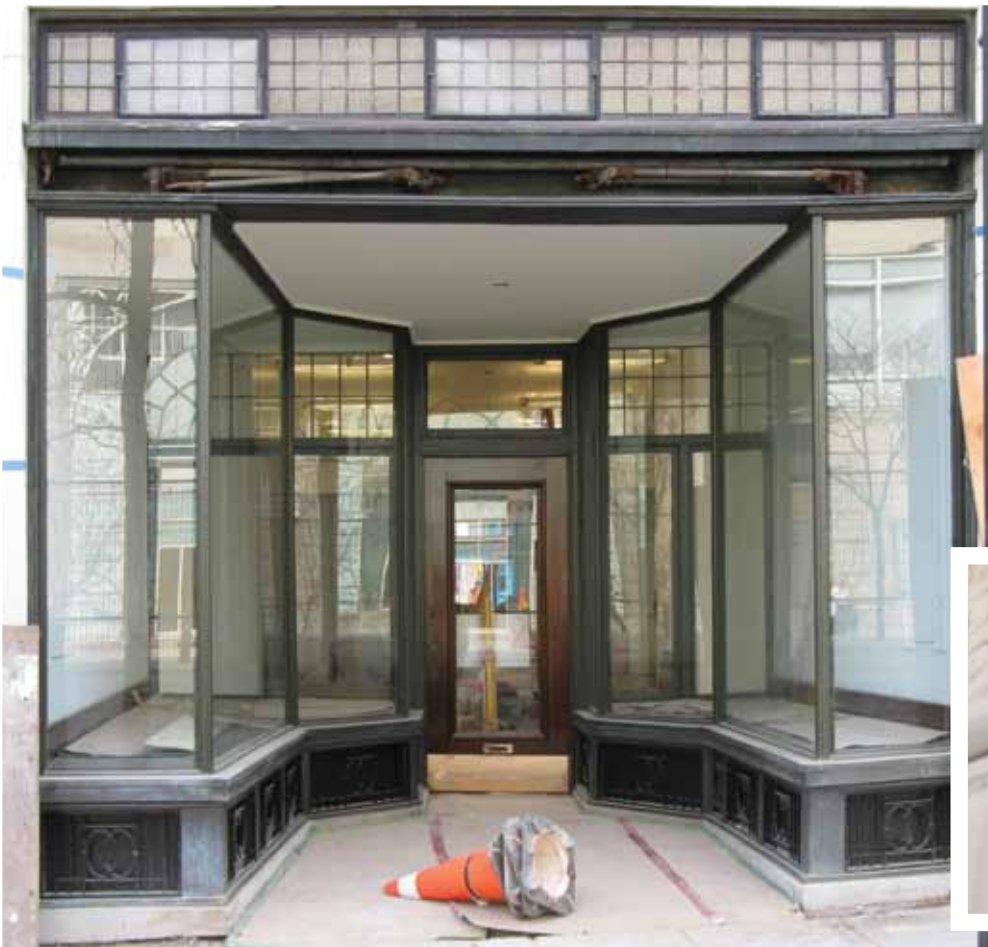
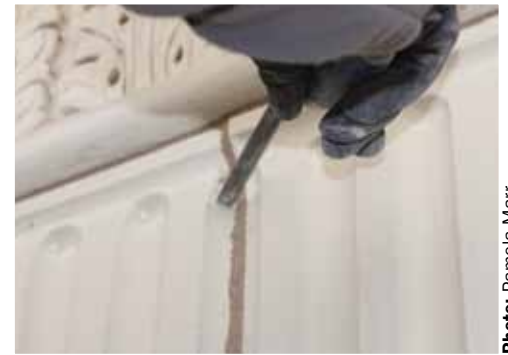
Enough material was salvaged to restore the decorative prism glass transom above a storefront on James Street North, complete with original grille work.

Inset: Detailed repairs of the exterior glazed terra cotta required the skills of traditional craftspeople.

to sixth floors and copper-framed storefront windows on the second floor were retained in the three most easterly bays on King William Street. The remainder were replaced with aluminium using a mid-rail detail and similar proportions to the originals. Decorative prism glass transoms and oak-trimmed storefronts with entrances on both King William and James Street North were restored or replicated.

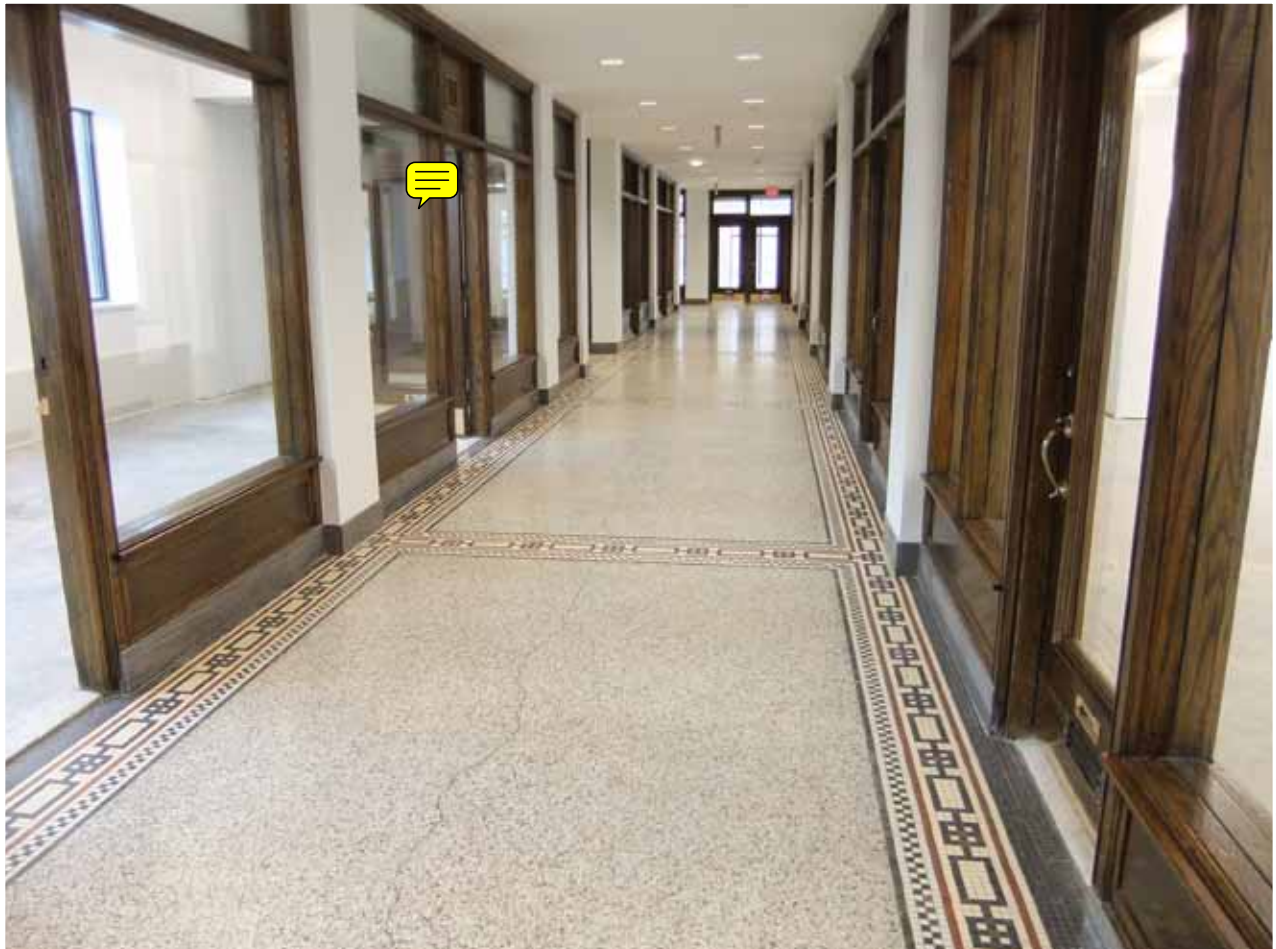
The impressive marble mosaic and terrazzo floor of the second-floor arcade and the decorative wood elements of the storefronts were repaired and retained.

On the second-floor arcade, the terrazzo floor with quarry tile border was found largely intact and storefronts were in better condition than those on the first floor.

Donovan Pauley, a masonry conservator from Clifford Restorations, surveyed the building and prepared a detailed repair strategy. Specialized craftsmen did the intricate restoration work of polishing the marble and then matching new tiles where needed. Coloured glass was found to match
