Masonry Restoration to HCF Headquarters

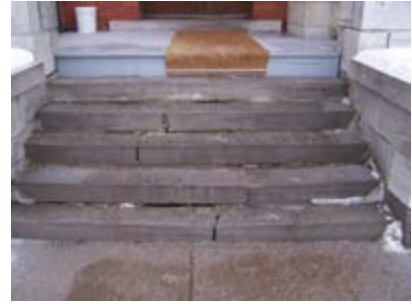
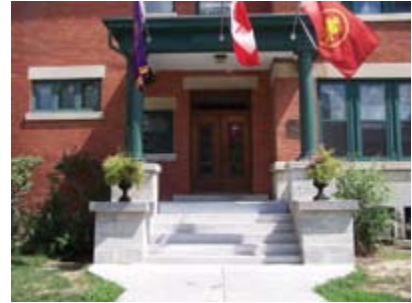
Built in 1905, the original five limestone front steps leading to the entrance of HCF's headquarters at 5 Blackburn Avenue in Ottawa were in varying stages of deterioration. Years of salt and moisture penetration had caused the stones to darken in appearance and horizontal fissures to have opened along the bedding planes. Only the top step remained in its original one piece. In addition, several of the stones in the two abutment walls had shifted badly; others were cracked; while one had deteriorated beyond repair.

Keystone Masonry undertook the restoration and replacement work. The hard modern masonry cement mortar was removed and replaced with a softer heritage lime mortar to help transfer the moisture out of the cavities of the abutment walls. The shifted stones were humoured back into position and those with severe cracking were repaired using stainless steel pins set in epoxy. The one severely deteriorated limestone block was replaced with a new one, hand finished to match the originals.

The steps themselves were dismantled and replaced with five new quarried limestone slabs, cut and hand finished to replicate the original bush-hammered appearance of the steps. The end result is a welcome improvement both visually and in terms of safety!
