## Taking it to the Street — Heritage Rehab Brings New Life to Downtown Saint John

by Jo Anne Claus and John F. Irving

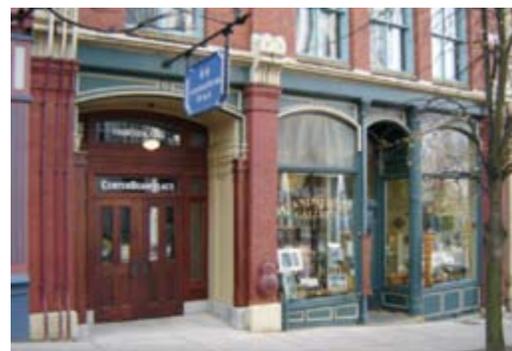
New wooden doors enhance the restored King Street entrance.

During the bylaw review process, a number of Irving’s initial ideas were modified. For instance, there was the issue of wooden doors on the entrance into a public lobby. The doors had to be new. Victorian retail buildings did not need a common lobby or a common door. The Irving-approved design was for structural glass doors on this lobby entrance to reveal the interior and to draw people in.

“The city’s heritage planner, Jim Bezanson, worked to persuade us that wooden doors were more compatible, more accurate,” Mr. Irving admits.

“We have to keep some buildings restored authentically, for ourselves and our children to understand the past. Jim and the Saint John Preservation Review Board were right. This project should have wooden doors amongst other important historical details,” he said.

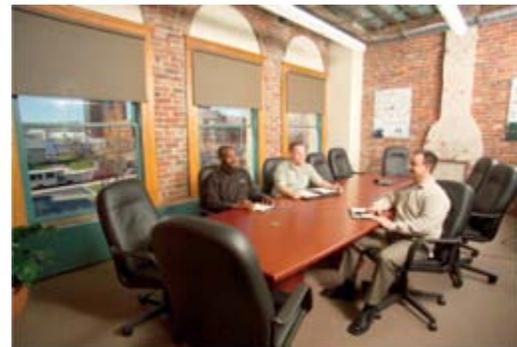
Historic and contemporary elements merge to form a new conference room.

“As well as facilitating the introduction of all new mechanical and electrical systems, we decided to expose the heavy timber and brick bearing wall construction as another way of unifying the project,” said Mr. Johnson. “In phase 1 we reinforced everything with great blocks of chunky wood held together with steel straps. We liked the look but, after discussion with Parks Canada, we decided to use more steel in phase 2 so the original columns can still be seen.”

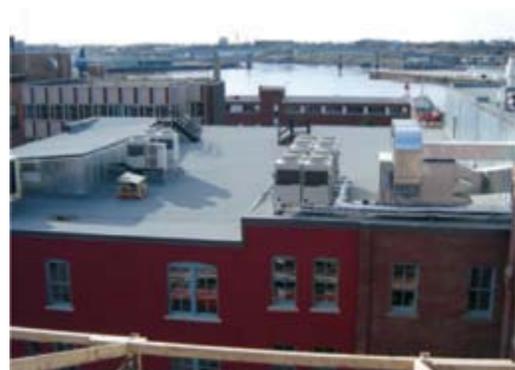
Roof repairs were extensive. Several beams designed to hold exterior walls to the building had rotted away.

“We expected roof repair would be a major job in these deteriorated buildings and we allowed for it in the budget,” Mr. Irving said. “We could see holes from years of neglect. When the roofing was stripped

though, we found the beams underneath had rotted away, beams that were supposedly holding exterior walls to the building. We found beams that were charred from past fires—all the stuff of nightmares.”

“For many years these structures had no purpose or use above street level, so quick patches were done instead of addressing the substantive issues,” he explained. “We have learned if brickwork repair has been neglected at roof corners and around window frames, there will be serious internal structural damage.”
